# NEWSLETTER

## IMPROVED REBUILT MOLD SHELL

FOR MACHINES  
BRANDED SIDEL\*

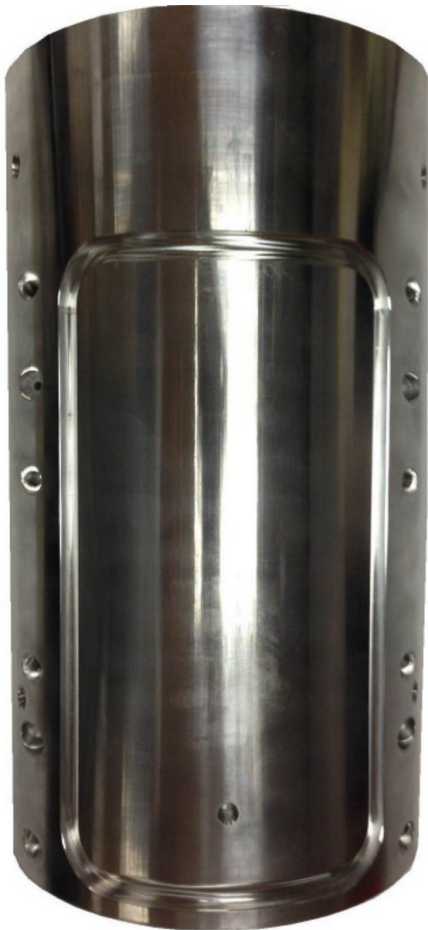
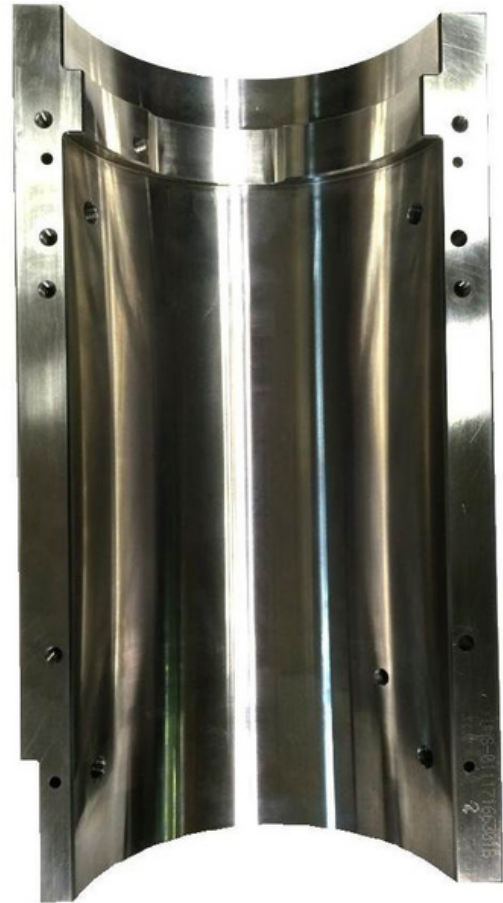
- ➔ Better aluminum grade than OEM
- ➔ Maintenance kit available
- ➔ Easy to rebuild in-house
- ➔ Cost saving
- ➔ Stainless steel channel, interchangeable, no corrosion
- ➔ Both sides, compensation and non-compensation available
- ➔ New mold shell also available
